To: Faranhyll Ranch HOA

RE: Summary Report: Doose Ditch Headgate & Pipeline Repair

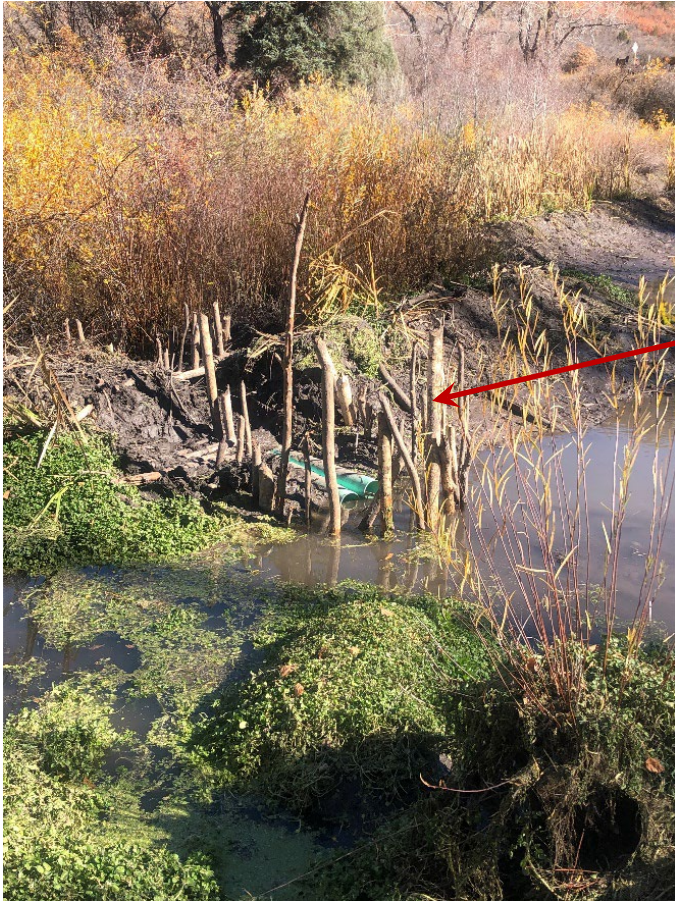
**Photograph 1.** Temporary drainage pipes placed in beaver dam.

Note temporary drainage pipes placed low in the beaver dam for drainage purposes. This dewatering helped lower the ground water table at the construction site.

1. The adjacent beaver ponds were temporarily drained in order to lower the water table in proximity to the project site. Lowering the water table was necessary to facilitate the headgate and ditch improvements. Dewatering the ponds became an on-going task for the HOA contractor as the beavers rebuilt their dams and/or plugged the inlet to the temporary drain pipes on a nightly basis. **Photograph 1** shows the drain pipes that were installed to allow pond lowering.

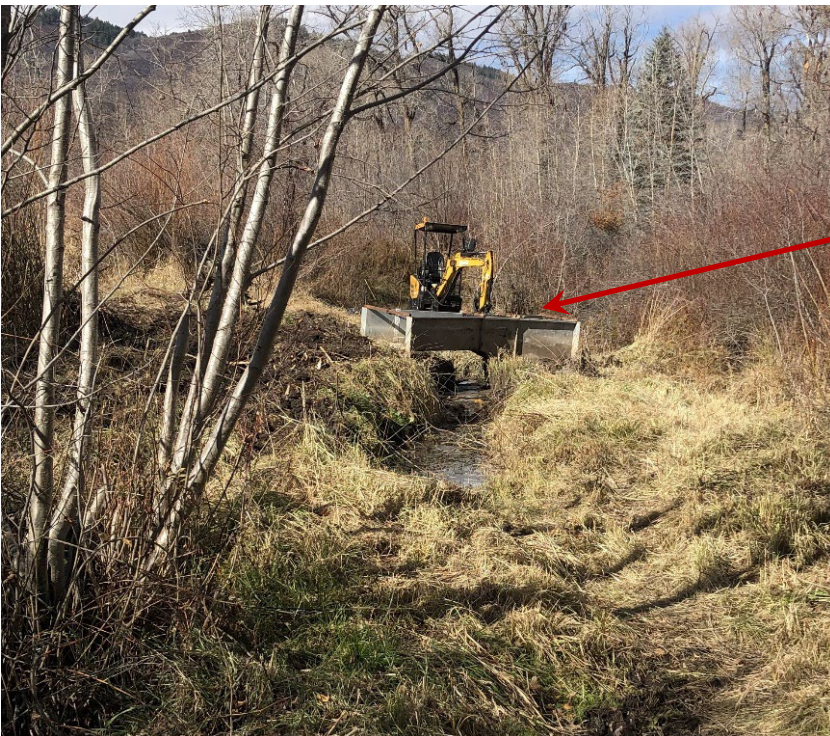
**Photograph 2.** Parshall flume is removed from ditch.

The Ditch's Parshall flume was removed and the resulting open section of the ditch was piped. The flume will be repositioned down ditch in spring 2024.

2. Once the groundwater elevation was lowered, the contractor accessed the site with construction equipment. The ditch's Parshall flume was removed and transported to a location on the ditch below the upper piped section (**Photograph 2**). The flume will be reset in the spring 2024 in consultation with the Division 5 Engineer.<sup>1</sup>
